SITE: IDEAL COOPERAGE
DATE: MAY 17-22, 1991
PHOTOS BY: P. DI PASCA (TAT)
PHOTOS BY: 2ND & 3RD WEEKS
DESCRIPTION: OF SITE ACTIVITY
(INCLUDES TEST PITS)

SITE: Ideal Cooperage, Jersey City, NJ DATE: May 17, 1991 PHOTO BY: P. Di Pasca, Weston TAT

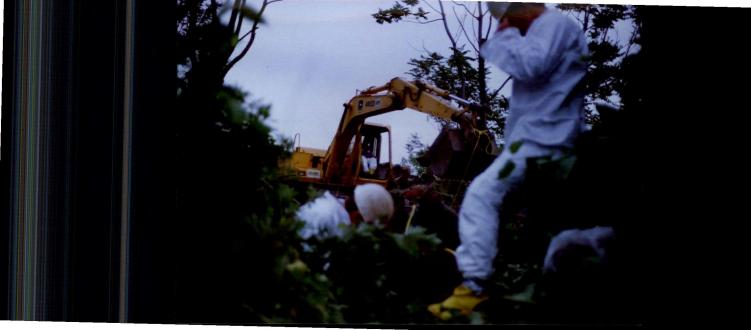
DESCRIPTION: Retrieval of waxy solid drum: from base of southern slope near railroad tracks

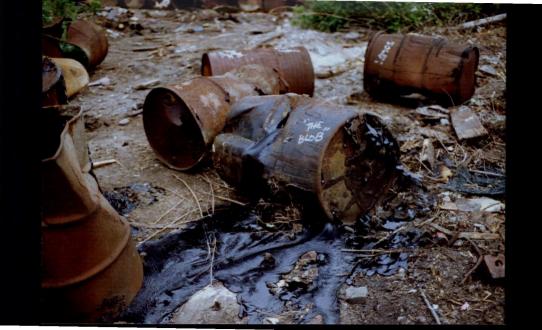
DESCRIPTION: Retrieval of waxy solid drums from base of southern slope near railroad tracks

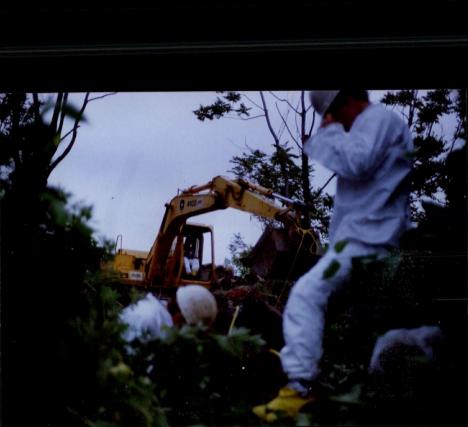
SITE: Ideal Cooperage, Jersey City, NJ
DATE: May 17, 1991
PHOTO BY: P. Di Pasca, Weston TAT
DESCRIPTION: Retrieval of waxy solid drum
from base of southern slope
near railroad tracks

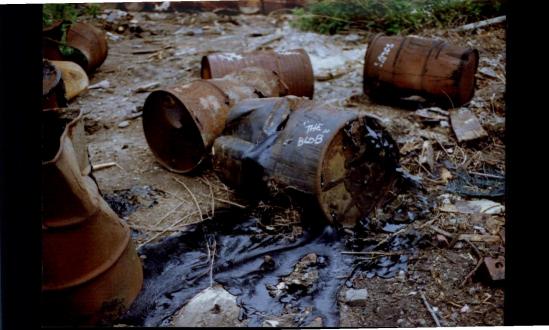
S DESCRIPTION: Retrieval of waxy solid drums
from base of southern slope
near railroad tracks

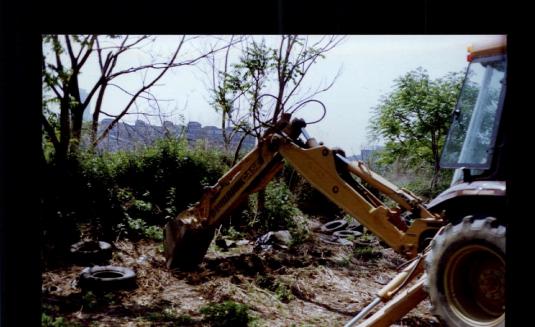
SITE: Ideal Cooperage, Jersey City, NJ DATE: May 22, 1991 PHOTO BY: P. Di Pasca, Weston TAT DESCRIPTION: Close-up of test pit # 1

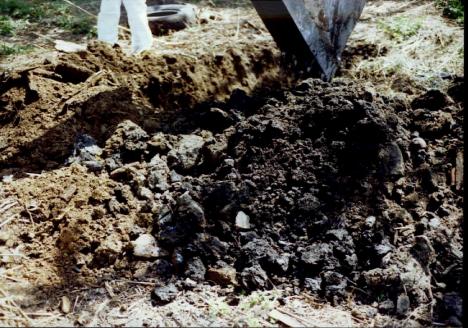
SITE: Ideal Cooperage, Jersey City, NJ
DATE: May 22, 1991
PHOTO BY: P. Di Pasca, Weston TAT
DESCRIPTION: Start of test pit # 3
excavation

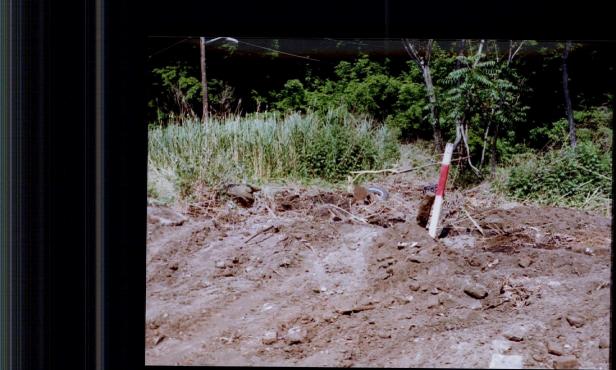
DESCRIPTION: Close-up of soil from test

pit # 3; depth = 1-2 feet;

HNu reading = 20-60

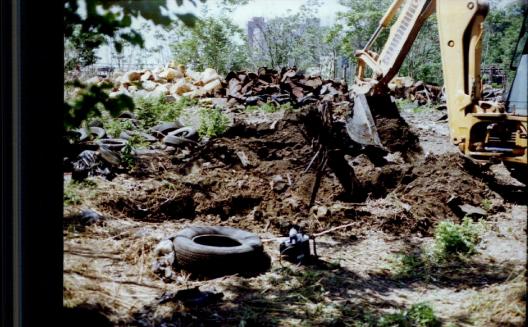
SITE: Ideal Cooperage, Jersey City, NJ
DATE: May 22, 1991
PHOTO BY: P. Di Pasca, Weston TAT
DESCRIPTION: Test pit # 2 after
backfilling

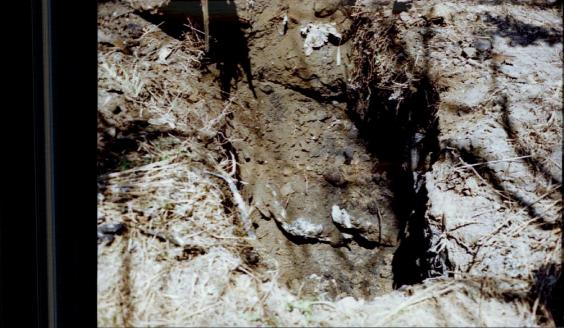
SITE: Ideal Cooperage, Jersey City, NJ DATE: May 22, 1991 PHOTO BY: P. Di Pasca, Weston TAT DESCRIPTION: Excavation of test pit # 3

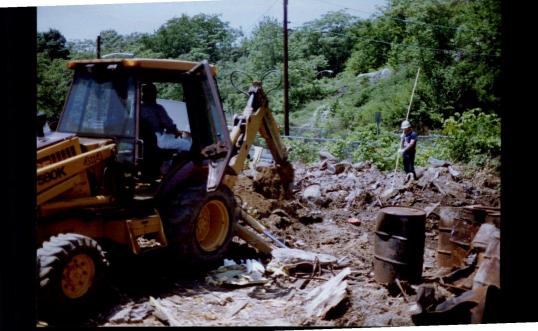
DESCRIPTION: Close-up of test pit # 3

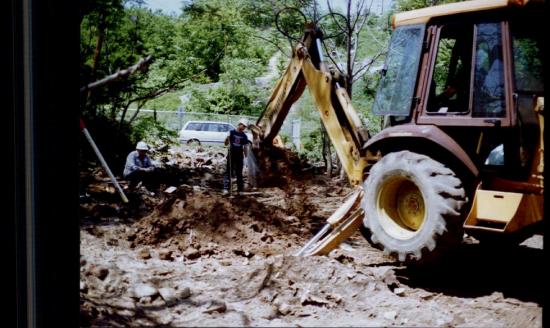
SITE: Ideal Cooperage, Jersey City, NJ
DATE: May 22, 1991
PHOTO BY: P. Di Pasca, Weston TAT
DESCRIPTION: Sampling of soil from test
pit # 5; depth = 5-5.5 feet

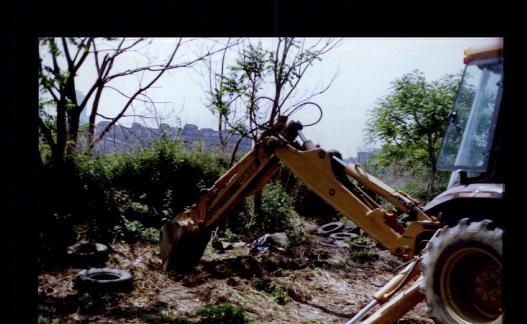
SITE: Ideal Cooperage, Jersey City, NJ DATE: May 22, 1991 PHOTO BY: P. Di Pasca, Weston TAT DESCRIPTION: Sampling of soil from test

pit # 5; depth = 5-5.5 feet

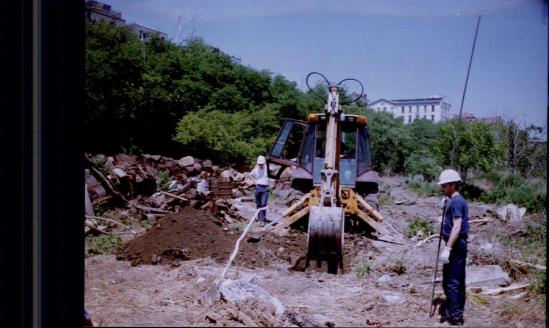
DESCRIPTION: Excavation of test pit # 6
